Measuring the protective role of clay-based renders in adobe masonry using thermal imaging and ultrasonic velocity imaging

G. Karagiannis^a, G. Apostolidis^a, M. Stefanidou^b

^a“ORMYLIA” Foundation, Art Diagnosis Centre, Ormylia, Greece

^bLaboratory of Building Materials, School of Civil Engineering, Aristotle University of Thessaloniki, Thessaloniki, Greece

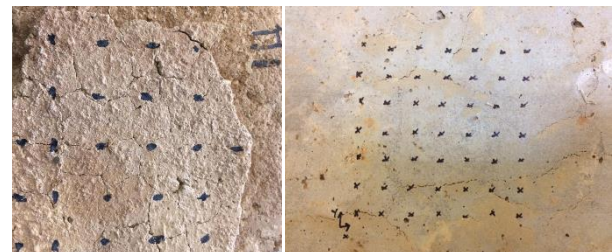
Sample of the clay bricks (adobes). Sample P1. Sample of the clay bricks (adobes). Sample P3.

In masonry units consisting of clay bricks (adobes) of 12×10×25cm two types of renders were applied. One was clay-based and the other was cement-based. The thickness of the renders was 7-10mm. The pathology of the clay renders was different in order to record the velocity propagation as well as the thermal behavior of the brick-render system. For that reason capillary cracks are present in some renders and in other case the adhesion of the render to the brick is loose.

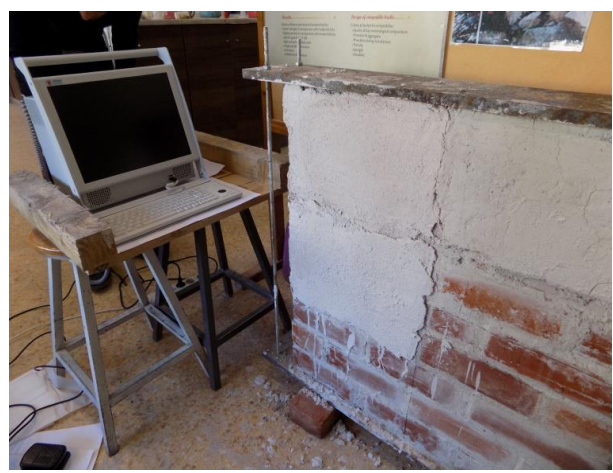
Application of the renders on the masonry sample.

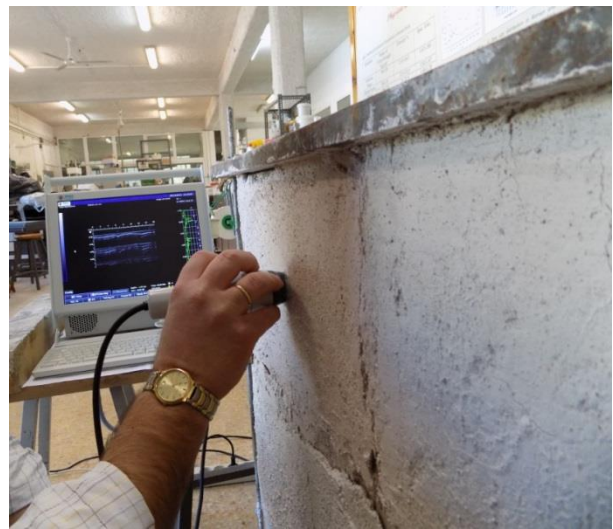
Scanning the masonry.

2. Ultrasound P/E or Transmittance
