## Material Characterisation of Stucco Decoration Fragments from the Early Byzantine Cathedral of Dion, Northern Greece

The objective of this analysis was to study the composition of the plaster used in the stucco decoration of Dion's Early Byzantine cathedral, by using **Non Destructive Testing Methods**. The main question that needed to be addressed was whether the material was lime or gypsum based.

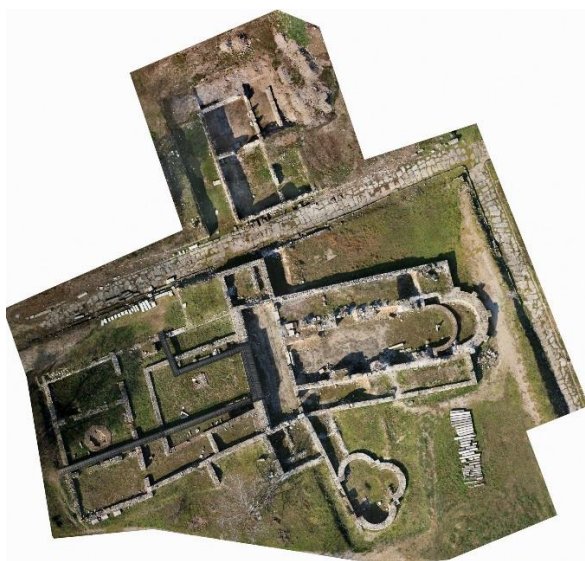
Figure 1

The Early Byzantine cathedral is among the most important monuments of the ancient city of Dion (fig. 1) and occupies a central position in the town plan. In its lifetime, the monument underwent two major building phases, which correspond to two successive churches, conventionally called Basilica A and Basilica B. Basilica A was a three-aisled timber roofed basilica that dates to the early 5<sup>th</sup> century AD. Of the interior decoration of Basilica A floor mosaics with geometric motifs are preserved in the nave and the narthex, while the Bema floor was laid with marble opus sectile.

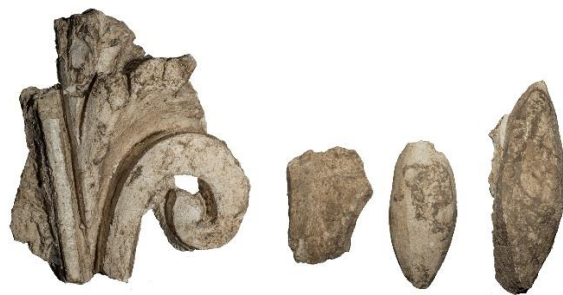
Figure 2

Moreover, the church was decorated with wall paintings supplemented by stucco reliefs, which presumably were placed on the upper part of the interior walls. From the scant fragments preserved, we can only conclude that they rendered architectural and vegetal decorative elements (fig. 2).

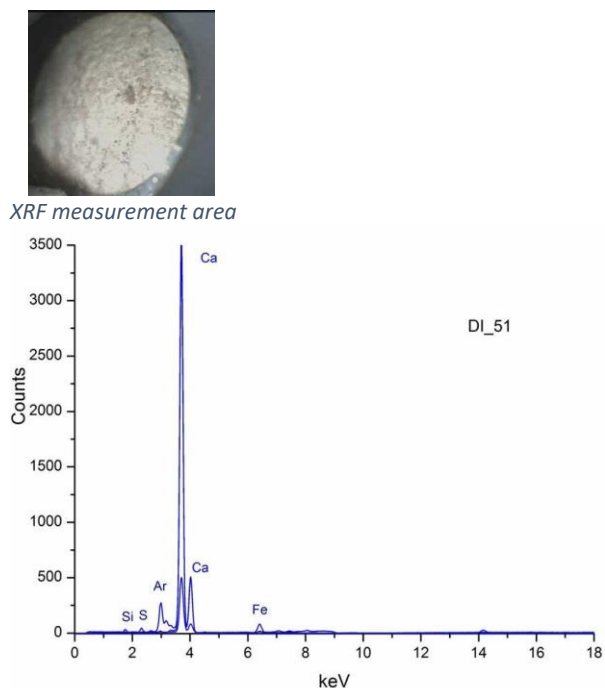
**Figure 3**

The XRF analysis revealed calcium (Ca) as the only major component, showing – in comparison to the identification of calcium carbonate (CaCO<sub>3</sub>) by microRaman spectroscopy – that the stucco

applied here was lime based (**fig. 3**). The secondary elements Si, Fe, Ni, Sr are commonly found in lime plasters.

Major elements Ca  
Minor elements Si, S, Fe, Sr, Ni

The overall evaluation of the analytical results derived from **XRF, microRaman and FTIR measurements** revealed the calcitic composition of the plaster decorations. The small amount of sulphur detected by XRF indicates that sulphation (gypsification) of calcium carbonate has occurred locally.

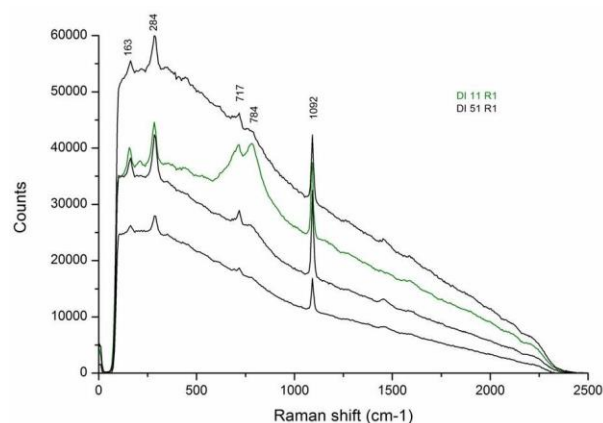
**Figure 4**

MicroRaman revealed the calcitic composition of the plaster reliefs (**fig. 4**). In comparison, the given diagram also shows the spectrum of a

similar fragment of stucco decoration from the Forum area (DI\_11). In this object, non-carbonised lime was also identified.
